भारत का राजपत्र The Gazette of India

रेल मंत्रालय
(रेलवे बोर्ड)

S.O. 580(E)—In their Notification No. 77/E(O)II/1/4 dated 30th June, 1977 published in Part II sub-section (ii) of Section 3 of the Government of India Gazette Extraordinary dated 1st July, 1977, Government appointed a Commission of Inquiry consisting of Shri Gangeshwar Prasad, a retired Judge of the High Court of Allahabad as its sole Member, to make an inquiry into the accident involving 13 Up Tezpur Express between Udalguri and Rowta Bagan stations on Rangliya-Rangapara North Section of the Northeast Frontier Railway on 30-5-77, state its findings as to the causes of the said accident and as to the person or persons, if any, responsible therefor and suggest safeguards against similar accidents in future. The Government also

Whereas the Central Government is of the opinion that it is necessary to appoint a Commission of Inquiry for the purpose of making an inquiry into the causes of the accident involving 13 Up Tezpur Express between Udalguri—Rowta Bagan stations on Rangiya—Rangapara North, Metre Gauge single line section of Alipurduar Division of the Northeast Frontier Railway on 30-5-1977.

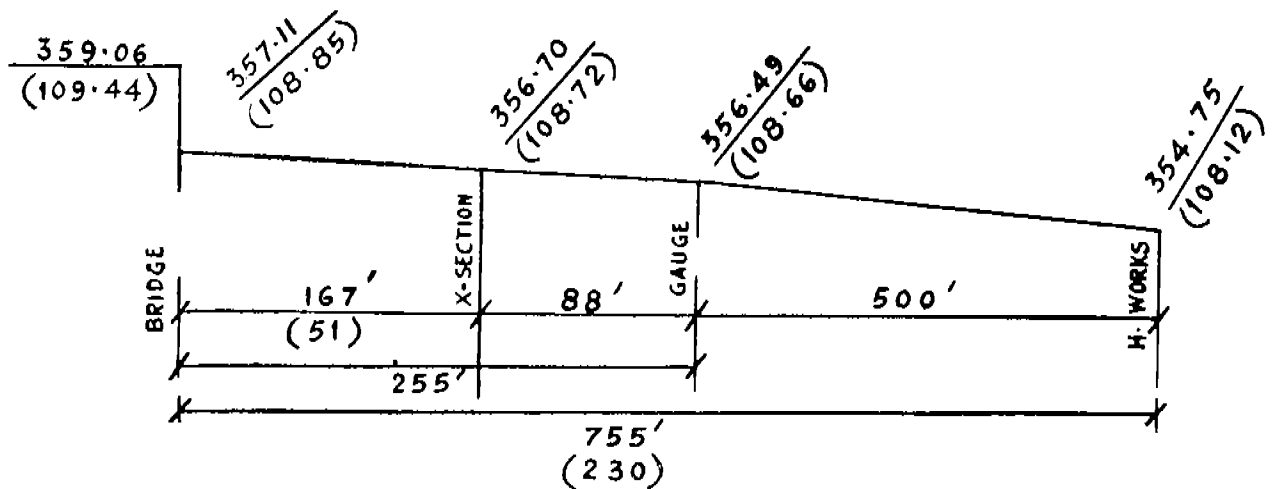
पुल सं० 139 से जल निकास

मीटर	फुट	मापन स्थल पर उच्चतम बाढ़ स्तर निकास	108.66	356.49
पुल सं० 139 के ऊपर उच्चतम बाढ़ स्तर	109.44	359.06	जल स्तर का प्रपात	ऊ० 0.78	2.57 फीट

मान लीजिए एच = 1.95' और एच 2 = 0.62

एच = एच 1 + एच 2 = 2.57'

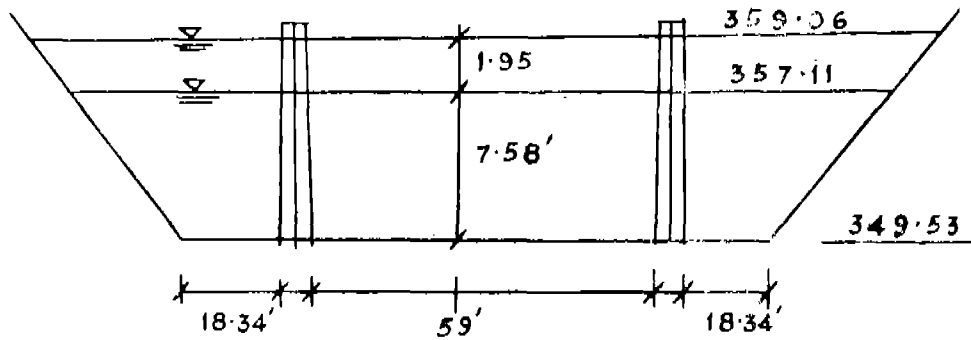
मीटर	फुट
प्रवाह स्तर	= 109.44	359.06
कल्पित प्रवाह (एच०घाई०)	0.59	1.95
नान-प्रवाह स्तर	= 108.85	357.11
पुल का क्षेत्रफल

(श्री भूयनारायण, अपर सिविल इंजी० द्वारा किये गये आकलनों आधारे पर=प्रदर्श : 43)

नदी स्तर क्षेत्र 357.11

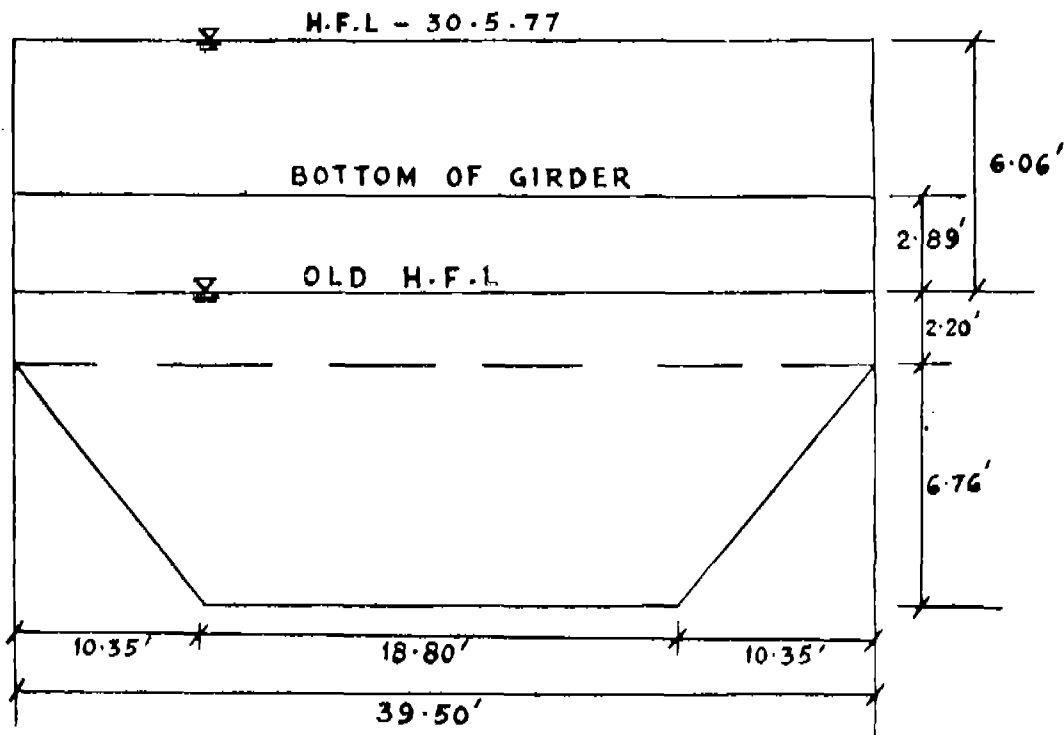
प्रदर्श: 43 (मापों में जहाँ वे मिलते नहीं वे कुछ आशोधन) में दिये गये खाँके के आधार पर निकाला गया अनुप्रस्थ खंड क्षेत्रफल

एच०एफ०एल० - 30-5-77

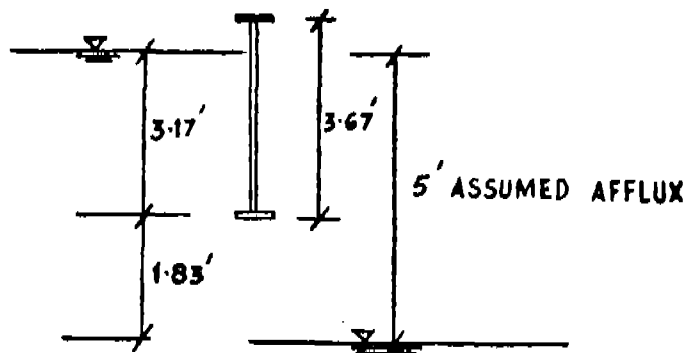
(30-5-77 के उच्चतम बाढ़ स्तर और पुराने उच्चतम बाढ़ स्तर के बीच का अंतर = $357.43 - 351.38 = 6.06$ —प्रदर्श 98 के अनुसार)

उच्चतम बाढ़ स्तर गार्डर के निचले भाग से $6.06 - 2.39 = 3.17$ फुट ऊपर है

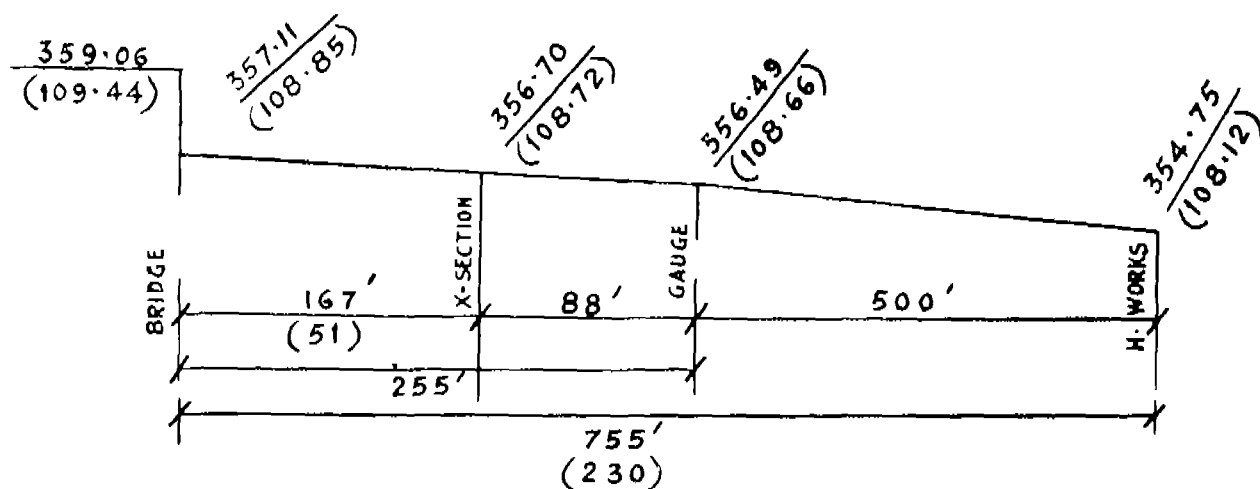
Discharge through Bridge No. 139

H.F.L. u/s of Bridge No. 139	=	M	ft.
		109.44	359.06
H.F.L. d/s of Bridge at the gauge location	=	108.66	356.49
Fall of water level = H	=	0.78 m	2.57 ft.

Assume	h_1	=	1.95' and h_2	=	0.62
	H	=	$h_1 + h_2$	=	2.57'
	S	=	$\frac{0.62}{255}$	=	$\frac{1}{411}$
				\sqrt{S}	= $\frac{1}{20.18}$

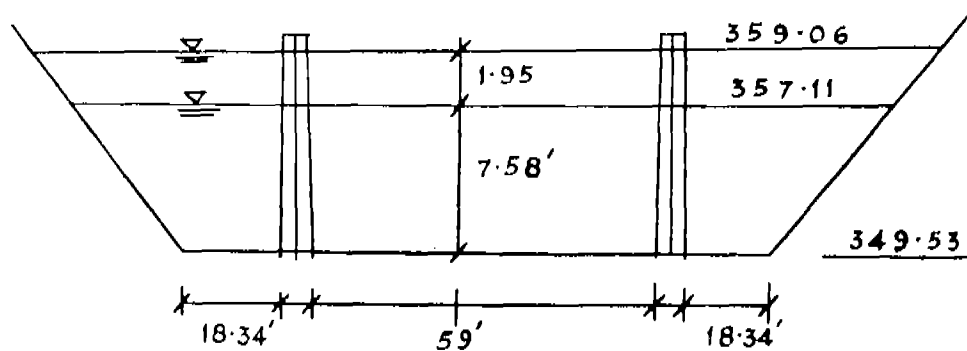
Discharge through the bridge opening

Metres	Feet
Affluxed level	109.44	359.06
Afflux assumed (hl)	0.59	1.95
Non-affluxed level	108.85	357.11
Area at the bridge		
(Based on calculations by Shri Suryanarayana, Addl. C. E. Ex : 43)

Area at RL 357.11

Sq. ft.	
(a) 60×7.58	= 435.8	
Less batter of piers $2 \times \frac{1}{2} \times 0.50 \times 7.58$	= -3.8	
Net	= 432.0	432.0
(b) $2 \times \frac{1}{2} \times 1.5 \times 7.58 \times 7.58$	= 86	86.0
(c) $2 \times 18.34 \times 7.58$	= 278.0	
Less batter of piers $2 \times \frac{1}{2} \times 0.5 \times 7.58$	= -3.8	
Total net area of opening	= 274.2	274.2
	Say	792.2
		792 sq. ft.

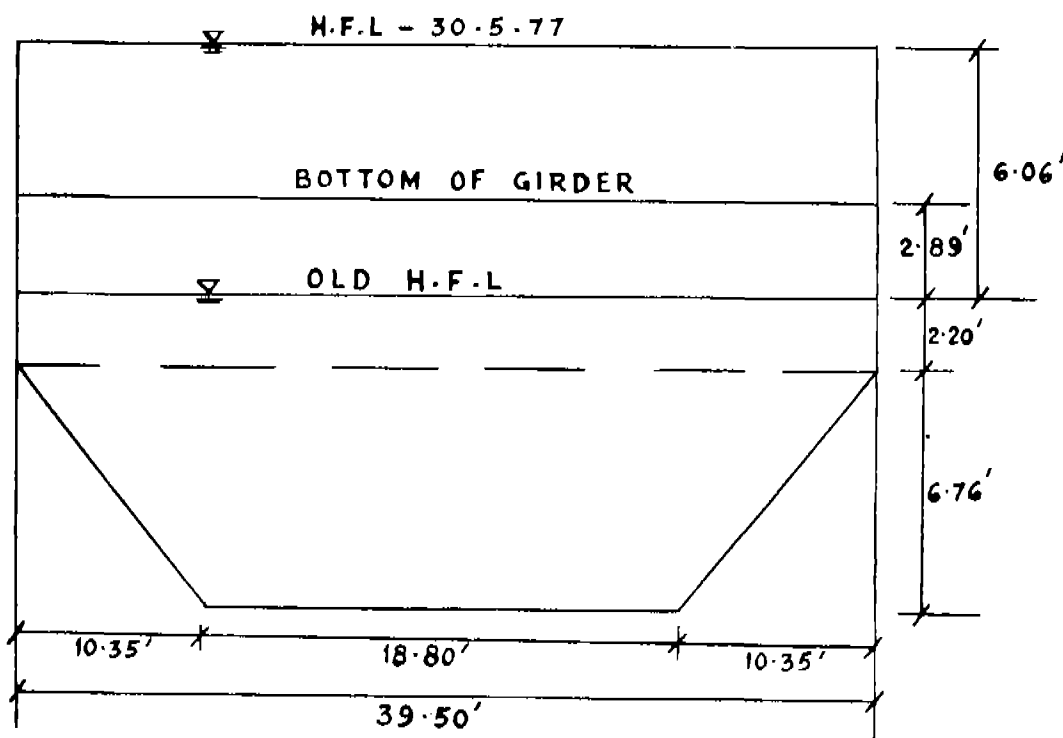
Calculation for discharge :

Cross section area worked out on the basis of sketch given in Ex : 43 (with slight corrections in dimensions, where they were found to be not consistent).

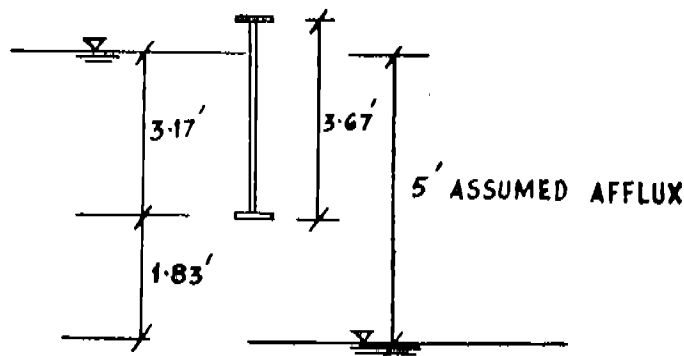
(Difference between H.F.L. on 30-5-77 and old

$$\text{H.F.L.} = 357.43 - 351.38 = 6.06 \text{—as per Ex : 96})$$

The H.F.L. is $6.06 - 2.39 = 3.17$ ft. above the bottom of the girder.
